PH PARAGLIDER HARNESSES

INSPECTION CERTIFICATE

Inspection certificate number: **PH_188.2017**

Name: **Roamer P** Size: **L**
Type: **ABS** Pilot max load [kg]: **120**
Impact pad type: **n/a** Weight [kg]: **1.6**
Serial number: **L-V3** Reception date: **21.10.2016**
Volume reserve parachute container [cm3] Min: **n/a**
Max: **n/a**

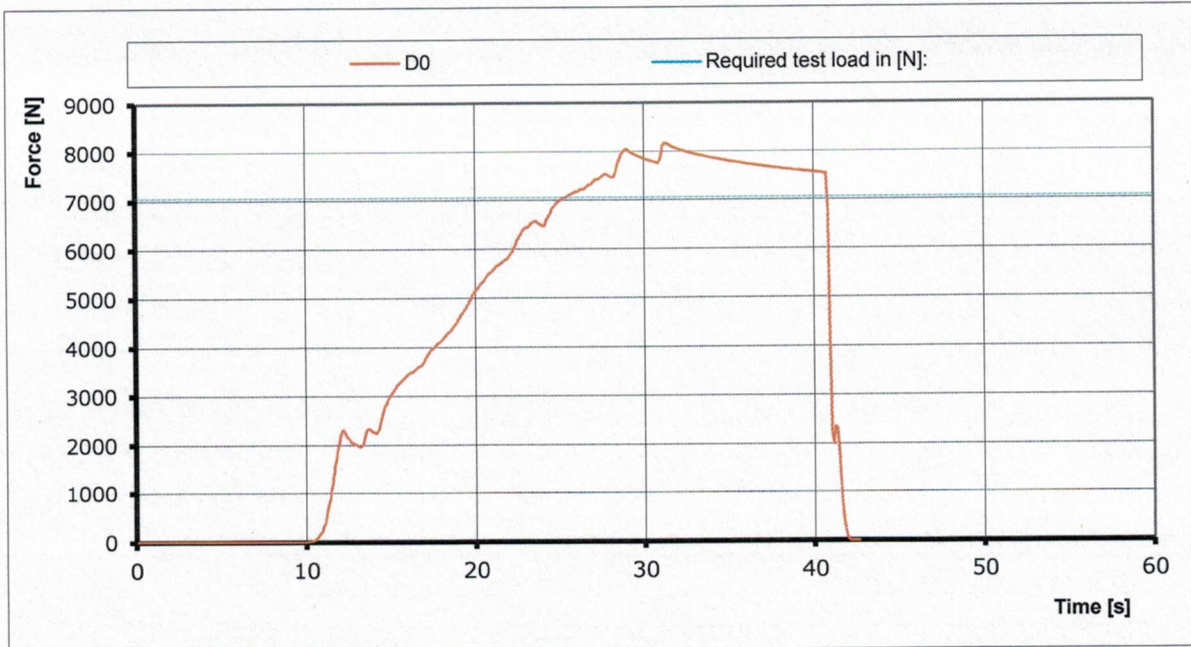
Graph: **D0**

Test setup: **Default flying position**

Required test load in [N]: **7063**

Duration of maintained min. load [s]: **15.21**

Any signs of structural failure after this test: **no failure**

Test result: **POSITIVE**

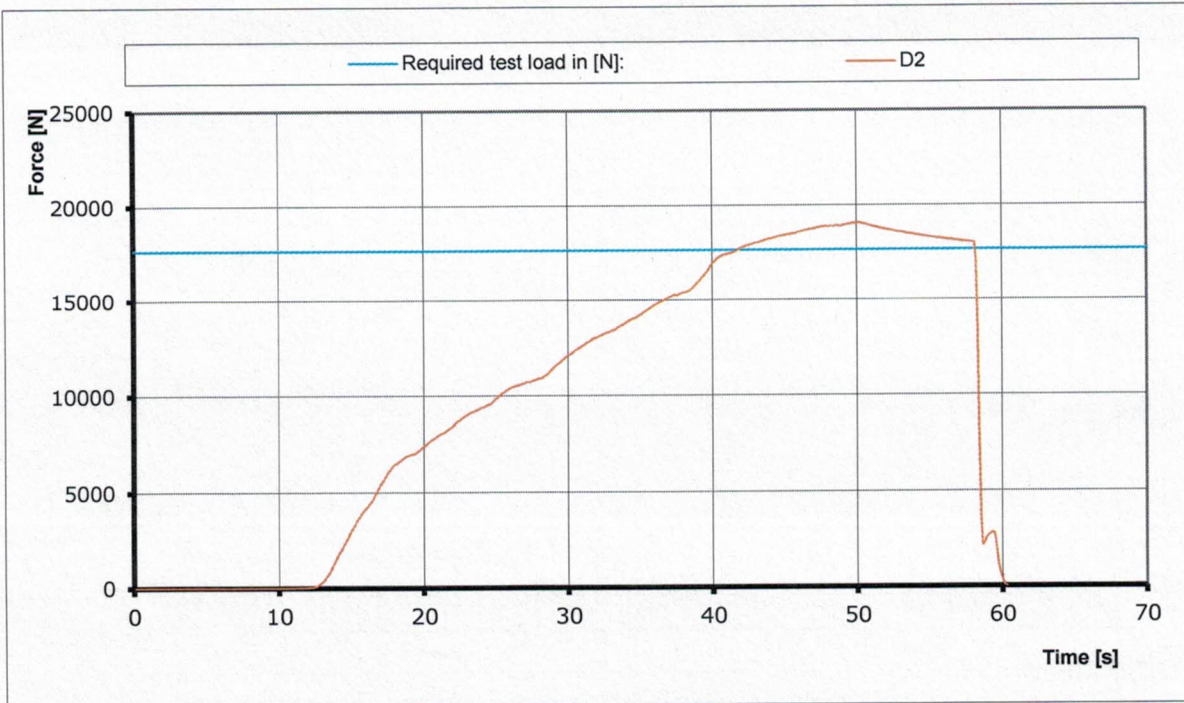
Duration of maintained min. load [s]: **16.19** [C°] **22.6**
 Any signs of structural failure after this test: **no failure** RH [%] **43**
 Test result: **POSITIVE** [hPa] **1017.3**
 Graph: **D2**

Test standard §: **5.3.2.2**
 Test setup: **Default flying position**
 Attachment points: **Both main riser attachments (3, 4)**
 Dummy: **Default, hip fixed (7, 8)**
 Required load in force [g] : **15**
 Model max load [kg]: **120**
 Required test load in [N]: **17658**
 Min. duration [s]: **5**

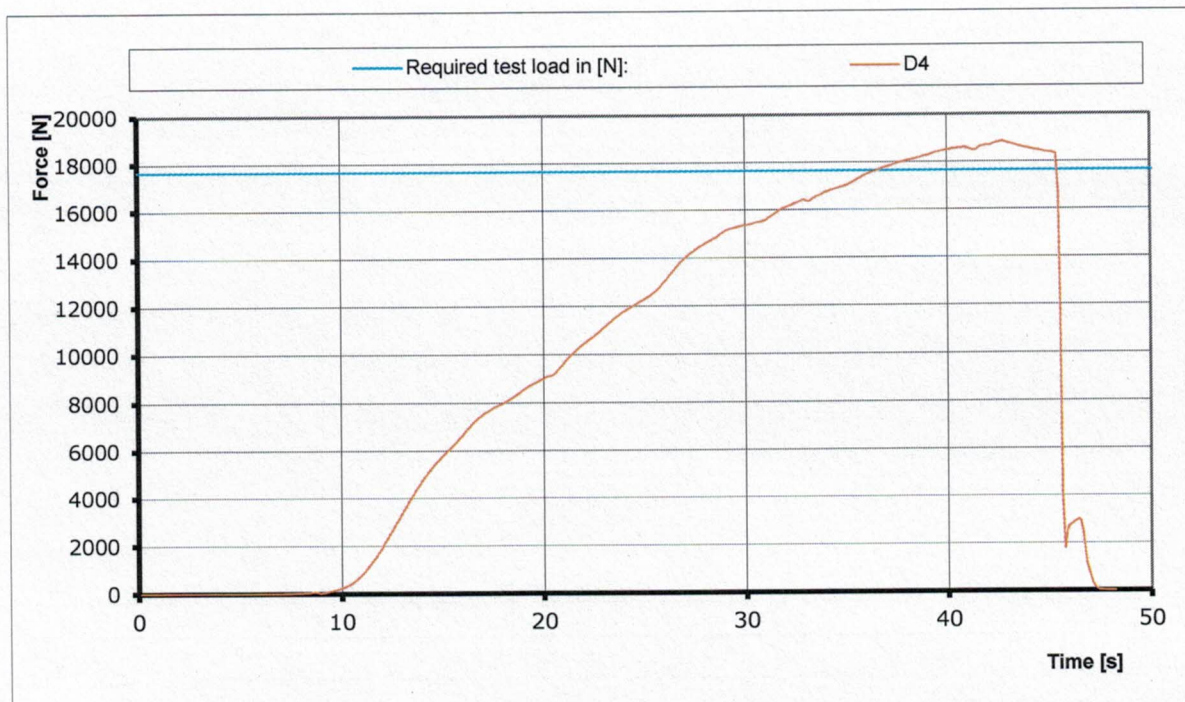
Graph: D4

Test setup: board (11) in landing position, leg straps (10) closed.

Required test load in [N]: 17658

Duration of maintained min. load [s]: 8.57

Any signs of structural failure after this test: no failure

Test result: **POSITIVE**

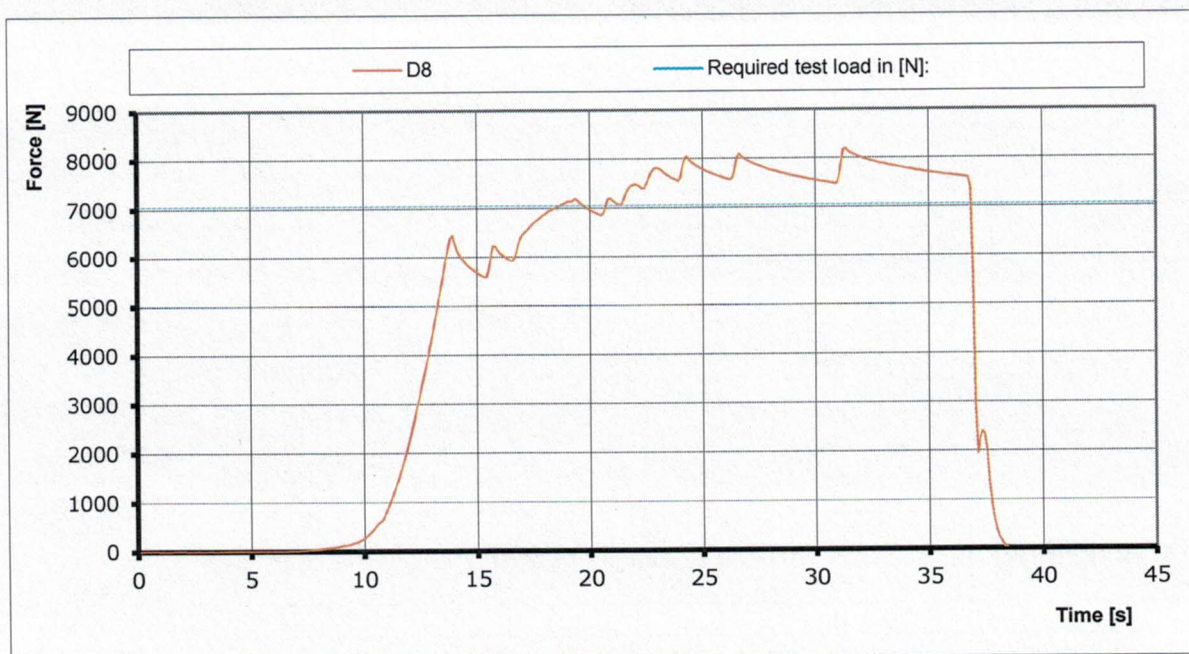
Graph: **D8**

Test setup: **Only one riser attached**

Required test load in [N]: **7063**

Duration of maintained min. load [s]: **17.98**

Any signs of structural failure after this test: **no failure**

Test result: **POSITIVE**

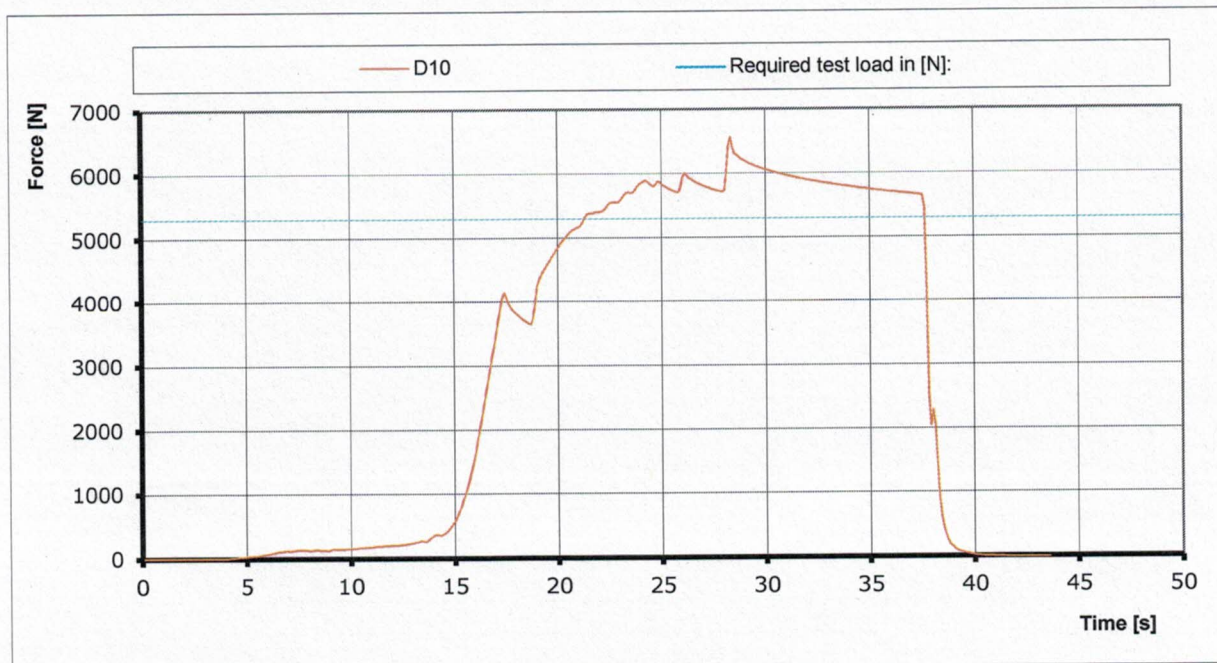
Test setup: **Normal flying position in NEGATIF**

Required test load in [N]: **5297**

Duration of maintained min. load [s]: **16.30** [C°] **22.6**
 Any signs of structural failure after this test: **no failure** RH [%] **43**
 Test result: **POSITIVE** [hPa] **1017.3**
 Graph: **D10**
